Inspection Report

Property Address:
183 Harwood Circle
Penfield New York 14625

VETERANS HOME INSPECTION SERVICES

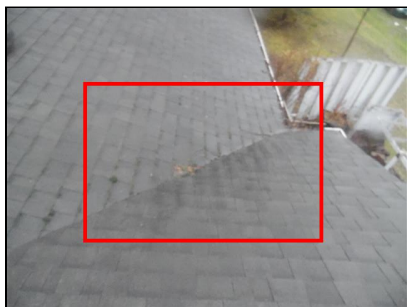
The roof covering is old, and the life of covering has expired. The covering does need to be replaced. Anticipate future replacement costs. Recommend replacement and further evaluation by a qualified roofing contractor for cost estimates and repairs. Some areas of moss growth were observed on the roof. Moss can lead to premature aging of the roof surface. Recommend that the roof is treated for moss.

1.0 moss on roof

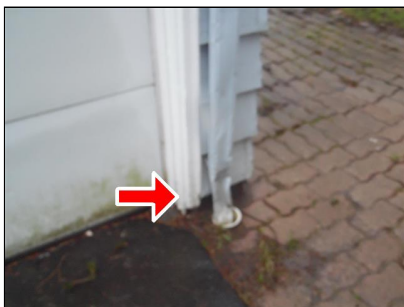
The ground drain lines need extending and burying below the surface. Most downspouts discharge across walkways and may present a slip hazard during winter months. Try to keep water drainage away from the foundation. Monitor and repair as needed. Downspouts that run into the ground are subject to backup/blockage. Neither the presence nor integrity of underground lines, nor free flow of water through such lines is determinable as part of this inspection. All gutters should have drain wire nets installed to minimize leaks and debris clogging the downspouts. Without wire guard nets in the top of the downspout the downspout will fill with water and break. Repair as required. The gutters are full of debris in areas and needs to be cleaned. The debris in gutters can also conceal rust, deterioration or leaks that are not visible until cleaned, and I am unable to determine if such conditions exist. In colder weather these gutters will fill with water and freeze. This condition may expand, clog and break the gutters or downspouts. If the "one downspout for every 20 feet of gutter" ratio is followed, then one linear foot of 5" gutter can handle the amount of water that gathers over 32 square feet of roof area if rainfall is about 3" per hour (heavy rain). You may consider adding an additional downspouts or install a 6" or wider gutter. The front side gutter is damaged and needs repair.

1.5 damaged downspouts

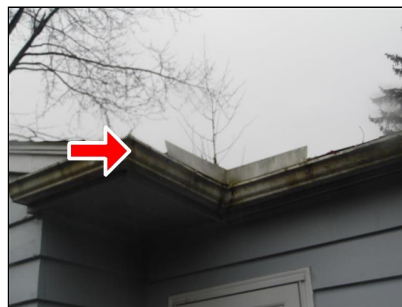
1.5 debris in gutters

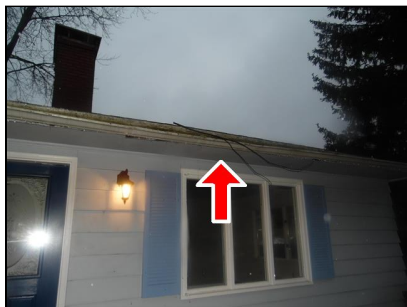
1.5 damaged gutter

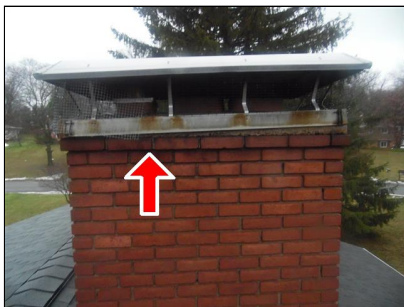
Slight cracking at the top/crown of the chimney was observed. Recommend sealing the cracks with caulk to prevent further cracking.

1.7 crown cracking and pointing

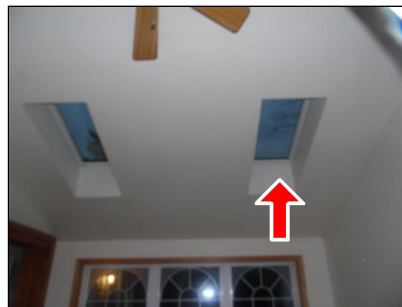
Skylights are particularly prone to leakage and may need periodic repair and or resealing. The integrity of the flashings is generally the first point to consider when leakage occurs. Surface damage or loss of the seal on insulated glazing can occur, but such a defect may not be readily apparent during an inspection. The skylights were not opened. The skylight windows are showing signs of fogging. Fogging in double pane windows is due to a broken or worn seal. In most cases, replacing the window is the best solution, although some companies will simply replace the seal. Recommend consulting a local residential window installer for future replacement costs as required.

1.8 fogging in window

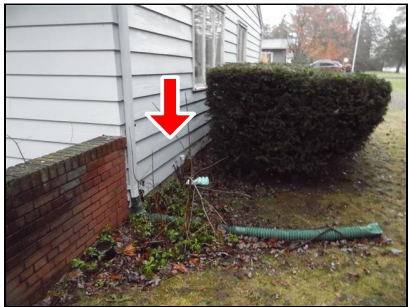
Negative grade noted at areas around the house, correct as required to maintain an adequate slope away from the foundation. This condition allows water to pool and penetrate the basement foundation. Maintain 4-6 inches below the siding as not to allow water to wick up into the framing. I recommend correcting landscape to drain water away from home.

2.0 low grade

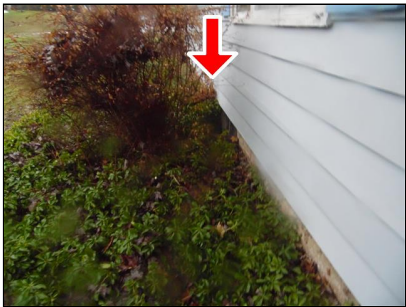
2.0 low grade back side

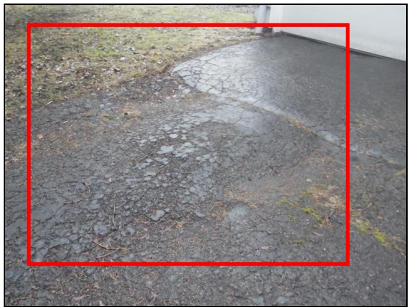
Settlement and cracking of the asphalt driveway was observed. Typical for the age of the home. Periodic sealing is recommended for asphalt surfaces. Recommend resurfacing or replacing the driveway. The left side walkway and porch are poorly installed. This condition will cause a trip hazard. Recommend replacement in accordance with local building standards.

2.2 resurface driveway

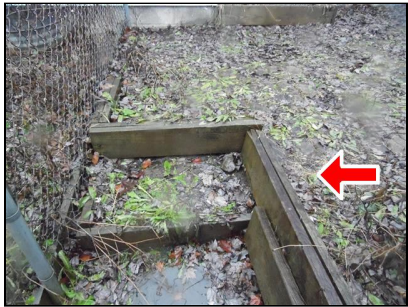
2.2 left side steps

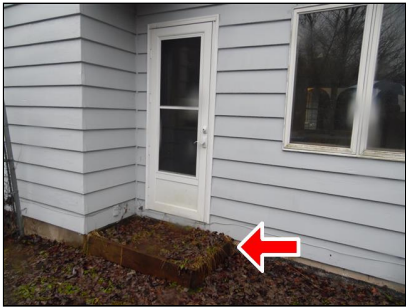
2.2 side door step

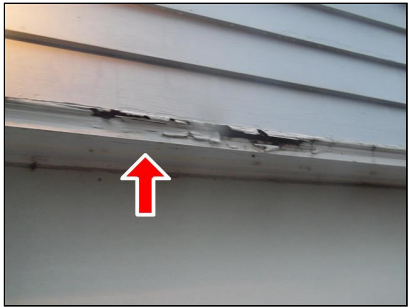
Water absorption into the siding is present and blisters and deterioration are observed in areas around the house. Maintain paint and caulk on all exterior wood and composite surfaces to minimize water damage. I recommend repair or replace of siding as necessary. The entire house needs scraping resealing, priming and painting. Maintain paint and caulk on all exterior wood surfaces to minimize water damage. Older homes have lead paint and tests should be conducted by an independent inspection if confirmation or a risk assessment is required by the lending agency. It is recommended that qualified contractors be used in your further inspection or repair issues as it relates to the comments in this inspection report.

2.3 water damaged wood trim

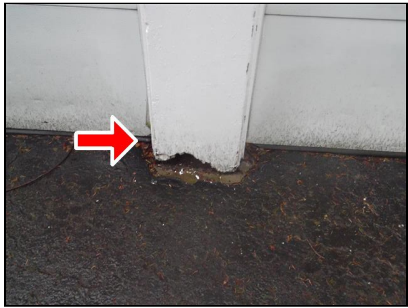
2.3 water damaged wood trim

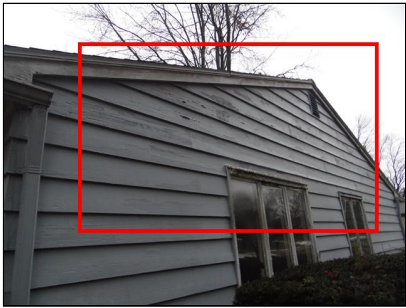
2.3 paint siding

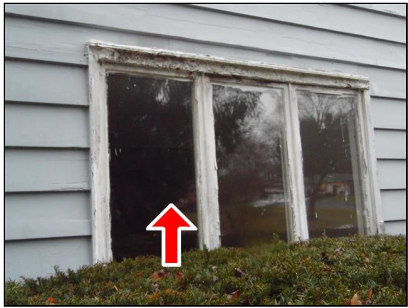
The wood trim and glazing is peeling paint at most wood trimmed windows. Further deterioration may occur if not repaired. I recommend maintaining paint and glazing on older wood units by a qualified contractor. Repair or replace as needed. Some exterior weathering, fogging between the glass panes was noted on several windows. Fogging in double pane windows is due to a broken or worn seal. In most cases, replacing the window is the best solution, although some companies will simply replace the seal. Recommend consulting a local residential window installer for future replacement costs if required. Exposed water damaged wood trim on several windows was observed. Maintain paint and caulk on all exterior wood surfaces to include doors and window frames to minimize water damage. Recommend replacing spongy wood window trim. I could not determine the extent of water damage to the interior framing.

2.5 water damaged windows

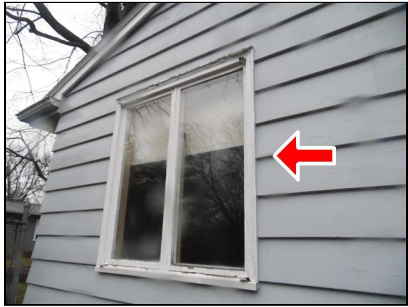
2.5 water damaged windows

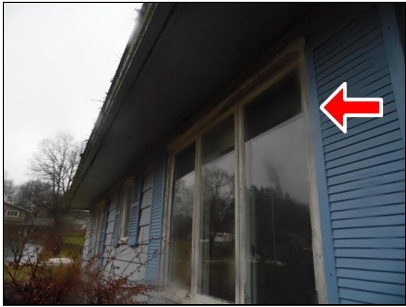
2.5 water damaged windows

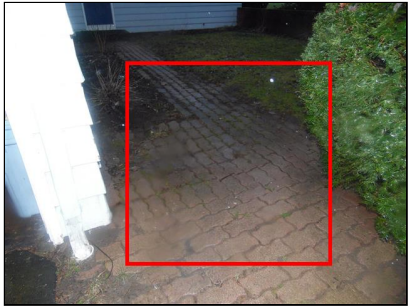
The front walkway has settled and are below grade. This condition will allow water to pool and penetrate the foundation. Recommend re-installing the pavers to improve the pitch away from the house and prevent a trip hazard.

2.6 settled pavers

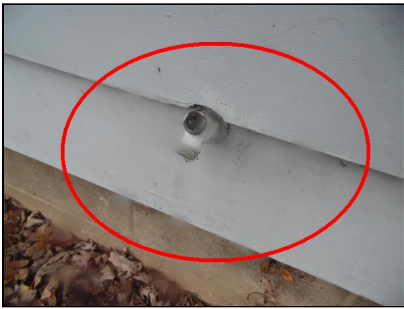
Old exterior hose bibbs/faucets were observed. Consider upgrade to frost free/anti siphon type units. Recommend disconnecting hoses and shut off during cold weather months. The exterior water faucet is broken and does not work. Recommend replacement.

2.8 broken water faucet

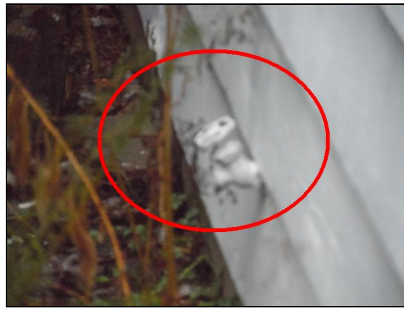
2.8 old style water faucet

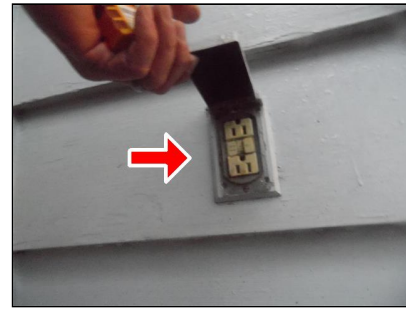
The side exterior outlet does not work. Recommend further evaluation and repairs by a qualifiedly electrician.

2.9 no power to outlet

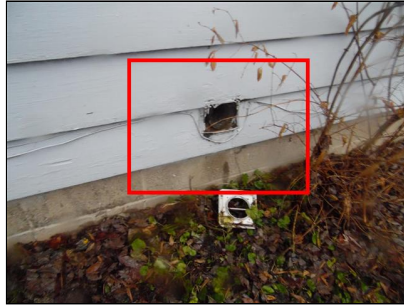
The dryer vent cover is broken. This may allow insects and pests to enter the house. I recommend repair or replace as needed.

2.11 broken vent

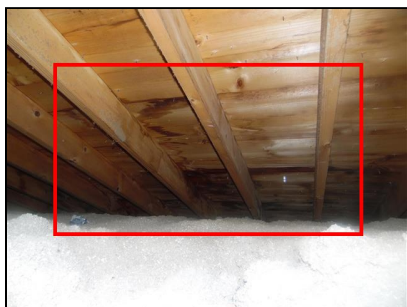
Numerous water leaks were noted on the rafters and sheathing. This condition may be caused by leaks in the roof covering or under the siding. Recommend further evaluation and repairs by a qualified roofer.

3.2 water leak

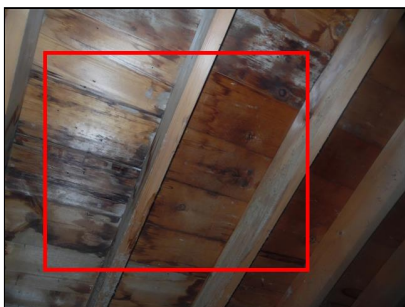
3.2 water leak

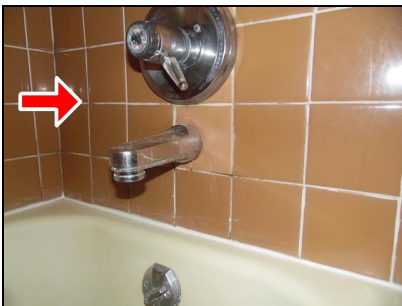
Loose tiles were noted in the bathroom walls. This condition will allow water to penetrate the walls. Repair as required. Consult with the homeowner for spare tiles before closing.

5.8.B loose tiles

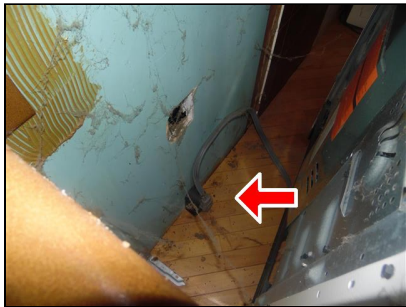
The stove outlet is not fixed to the wall. This condition may allow an extreme safety hazard if water over flows and energizes the appliances. Movement of the appliance may also damage the cord or outlet box. Recommend securing the 220 outlet to the wall at a height of 8 inches to prevent damage and electrical hazard. Consult with an electrician for local ordinances and evaluation. The sheathing on the power cord has deteriorated and has exposed wires. This a safety issue that needs immediate attention. The agent and client were notified.

6.10 outlet on floor

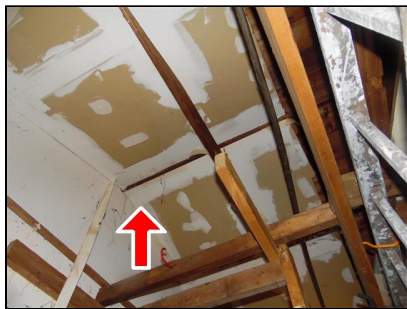
7.1 retape seams

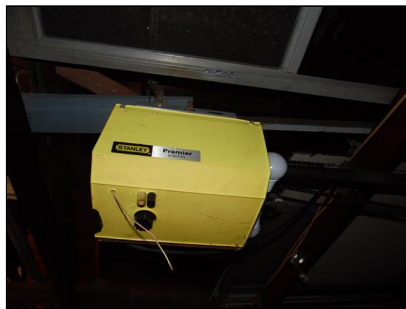
7.7 replace opener

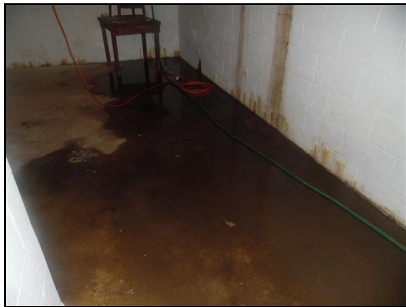
8.0 pooling water

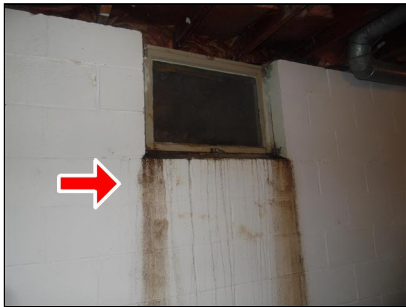
8.0 water penetration

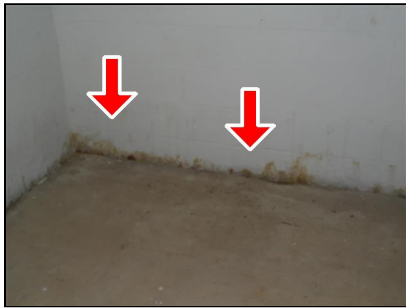
8.0 water penetration

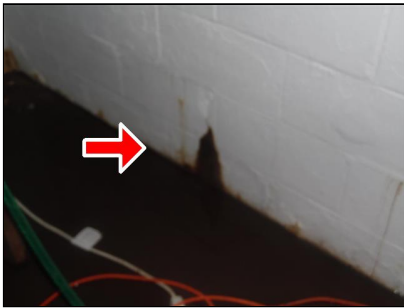
8.0 water leak penetration

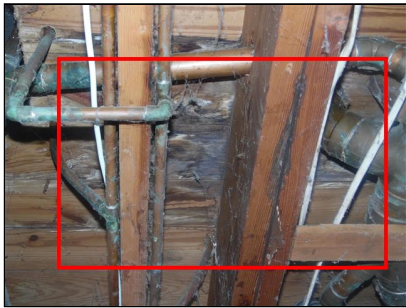
8.4 water damage under bathtub

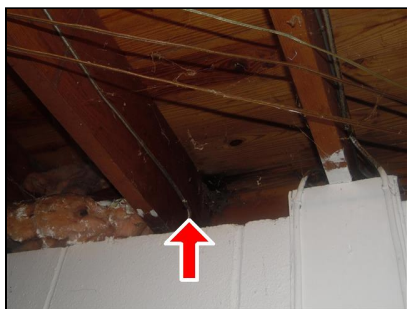
8.4 active water penetration front wall

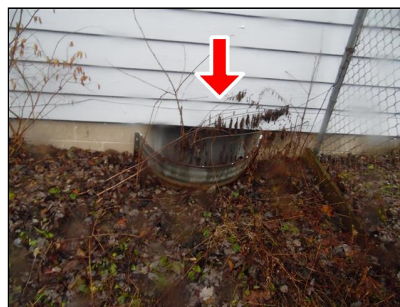
8.8 disconnected window wells

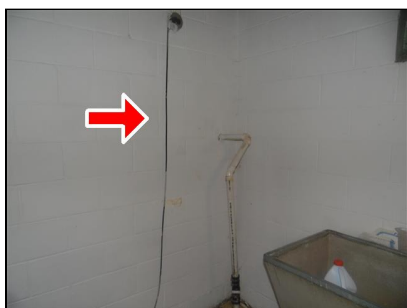
9.5 pump cord

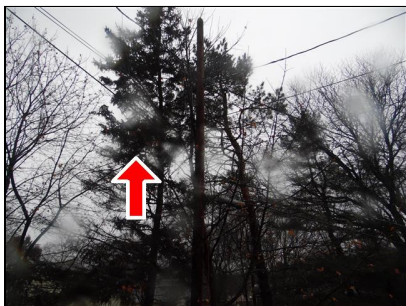
11.0 service cable thru tree

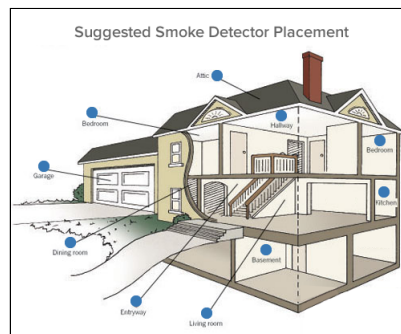
No CO detectors were observed in the house. Most manufacturers installation guidelines require a CO monitor installed along side gas appliances. This is to notify home owners of CO buildup in enclosed areas. Modern building practices require at least one CO monitor in a home. Recommend one CO monitor on each floor and in each sleeping area installed lower than beds in the room.

11.6 smoke alarms
