Inspection Report

Property Address:
1600 Penzsilvania Drive
Fairport NY 14618

VETERANS HOME INSPECTION SERVICES

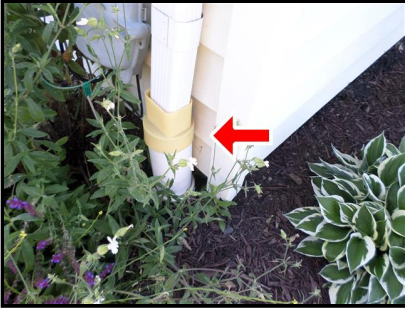
1.5 Item 1(Picture)
downspout

1.5 Downspouts that run into the ground are subject to backup/blockage. Neither the presence nor integrity of underground lines, nor free flow of water through such lines is determinable as part of this inspection.

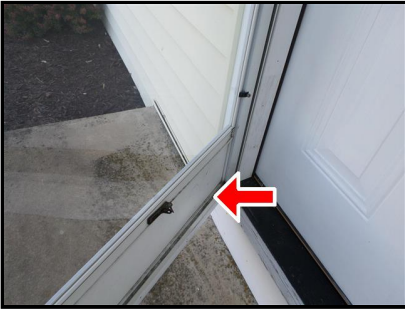
2.0 Item 1(Picture) missing door closer

2.0 The front screen door is missing a pneumatic closure. Pneumatic pumps use trapped air or liquid to slow the closing process, prevent slams, and gently bring the door to the closed position. Repair as required.

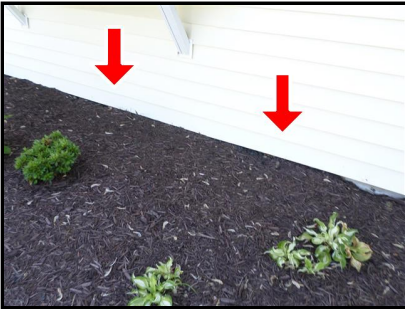
2.1 Item 1(Picture) mulch is high

2.1 Siding in contact with ground/mulch at front and rear sides of home. This condition may allow water to wick up into the wood framing and provide insects with an accessible route into the house. Recommend a minimum ground clearance of six to eight inches where possible.

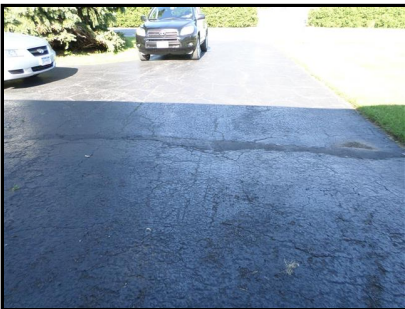
2.2 Item 1(Picture) driveway

2.2 Settlement and cracking of the asphalt driveway was observed. Typical for the age of the home. Periodic sealing is recommended for asphalt surfaces.

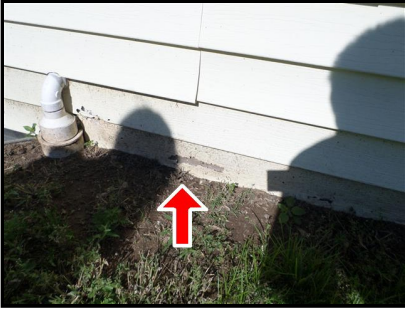
2.4 Item 1(Picture) damaged vinyl siding

2.4 Some damaged vinyl siding was noted in the rear of the house. This was probably caused from a weed wacker. Repair as required.

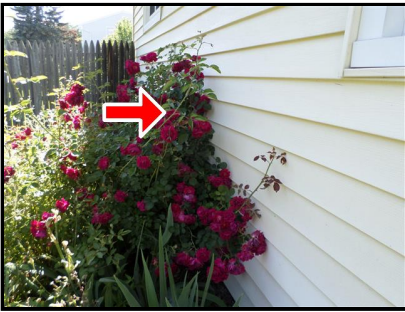
2.7 Item 1(Picture) overgrown vegetation

2.7 Homeowners should trim all trees, shrubs and other vegetation should be kept trimmed away from the house and roof. This helps prevent insect infestation and water damage. Provide a proper distance allowing a workman to conduct repairs around the house. Recommend a minimum clearance of 12 to 18 inches where possible.

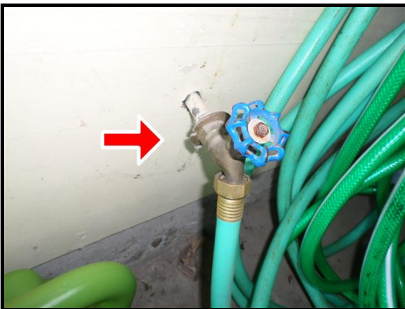
2.9 Item 1(Picture) garage water bib

2.9 Old exterior hose bibs observed in the garage. Consider upgrade to frost free/anti siphon type units. Old fixtures and/or faucets will require above normal maintenance; plan to replace now or in the near future. The feasibility of replacement, as opposed to repair, will increase with age.

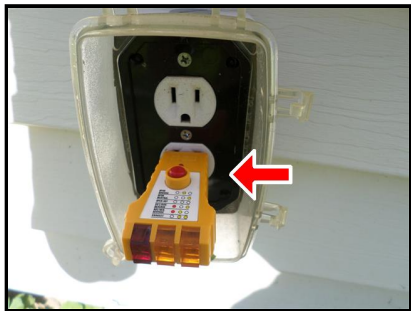
2.10 Item 1(Picture) exterior outlet

2.10 The exterior circuit was not GFCI protected. Ground-Fault Circuit-Interrupters (GFCIs) are generally advised (if not required) for general circuits in areas exposed to weather. The outlet gang box is poorly secured to the house. A qualified electrician should correct as required for safety

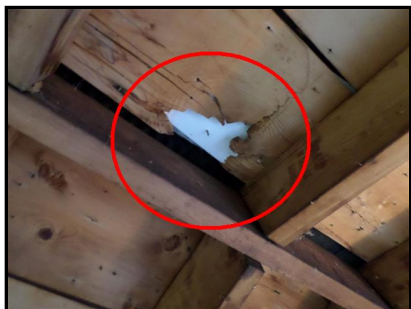
3.0 Item 1(Picture) hole in sheathing

3.0 A hole was observed in the garage roof sheathing. No issues were observed during the inspection. Caution people working or walking on the roof about this situation. Repair as required.

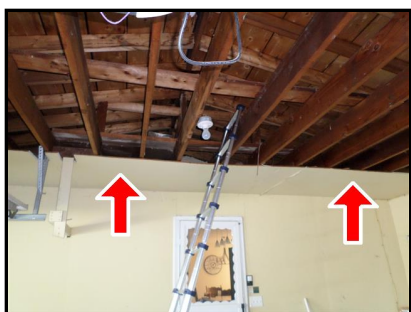
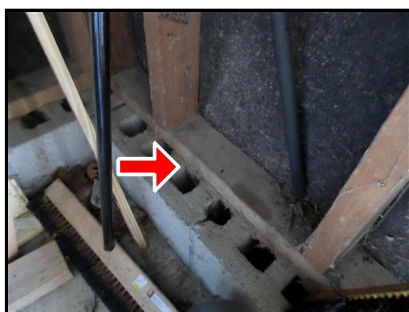
3.1 Automatic closing devices are also commonly required for this entrance door. Recommend replacing the hinge with a self closing type door hinge. This will minimize carbon monoxide gases from entering the home and improve energy efficiency. There was no firewall noted between the garage and the house. This condition would allow a potential fire to spread from the garage into the house and is considered unsafe until corrected. A qualified contractor should correct for safety. No anchor bolts were set into the block supporting the garage wall. These bolts if present would secure the wall to the foundation. Repair as required.

3.1 Item 1(Picture) No firewall

3.1 Item 2(Picture) No anchor bolts

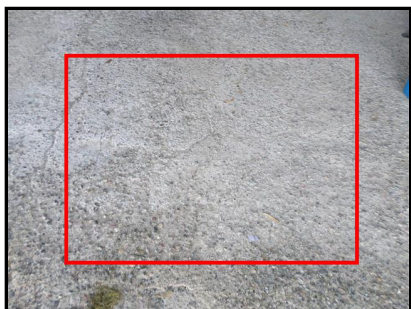
3.2 Item 1(Picture) spalling

3.2 Spalling and cracking was noted on the garage floor. Rain and melting snow will seep through the top layer of the concrete, pooling underneath. When this water freezes, it expands and pushes upwards. This pressure causes the top layer of the concrete to spall, creating chipping, flaking, scaling, and similar concrete damage. This is typical for the age of the home. Monitor and repair/resurface/seal as required.

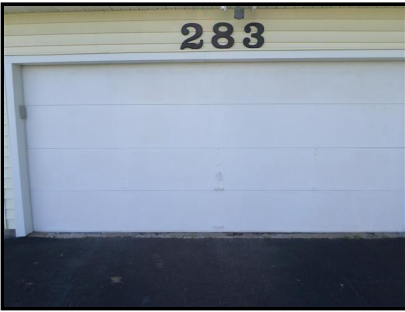
3.3 Item 1(Picture) older garage door

3.3 Older garage door. Some dents were observed.

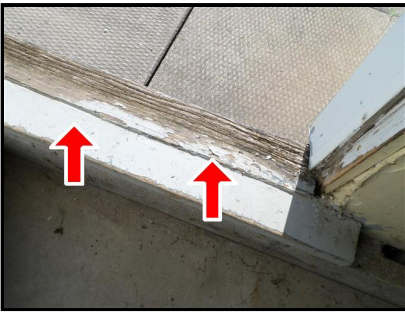
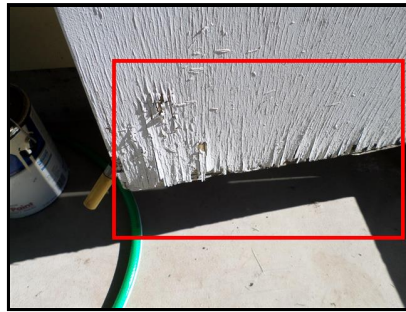
3.4 The doors and sills on both occupant garage doors were weathered and need of repair. Recommend scraping, priming and repainting to stop further water damage to the sill. Consider adding deadbolts to both doors for added security.

3.4 Item 1(Picture) door frame

3.4 Item 2(Picture) weathered door

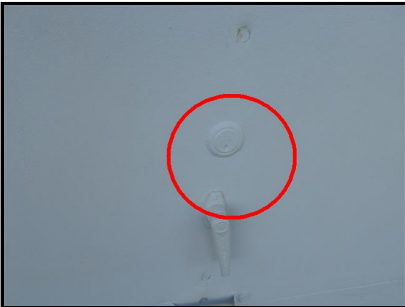
3.7 Item 1(Picture) painted lock

3.7 The garage door lock was painted over and not functioning. Repair as required.

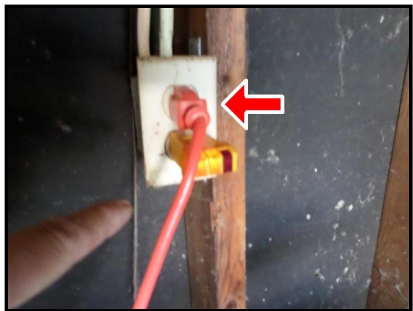
3.11 Item 1(Picture) No GFCI

3.11 Two garage outlets were not GFCI protected. Ground-Fault Circuit-Interrupters (GFCIs) are generally advised (if not required) for general garage circuits in garages. A qualified electrician should correct as required for safety. One outlet at the rear of the garage was loose. This may cause a short in the gangbox if allowed to remain as is.

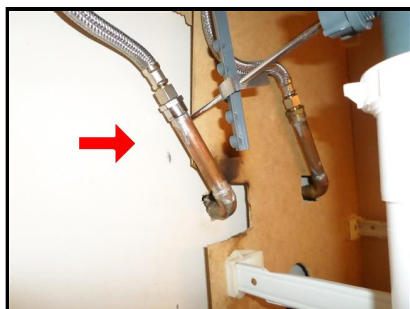
5.4 Item 1(Picture) No shut off valves

5.4 No shut off valves were noted in the hallway bathroom sink. Shut off valves allow quick shut off capability during emergencies or replacing fixtures. Consider installing shut off valves during future upgrades.

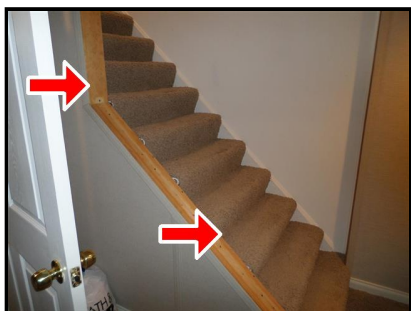
6.3.C Item 1(Picture) missing handrail

6.3.C No Handrails along the bottom stairway in the basement were noted. Handrails are required along any stairway and they must be graspable and securely fasted to a wall and or supports. Recommend installing a handrail in the basement stairway.

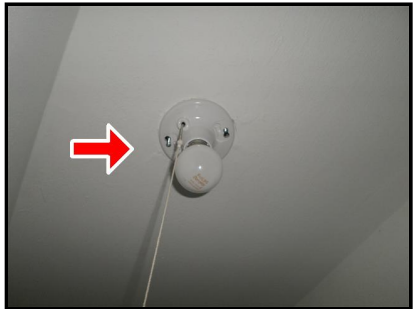
6.6.D Item 1(Picture) closet light

6.6.D Most of the closets were equiped with incandescent light fixtures. Exposed light bulbs in closet areas should have a minimum safe distance of 18 inches from any flammable materials. Fluorescent lights must maintain minimum of 6 inches clearance from flammable materials. Recommend removing flammable materials to a safe distance or replace with fluorescent lighting.

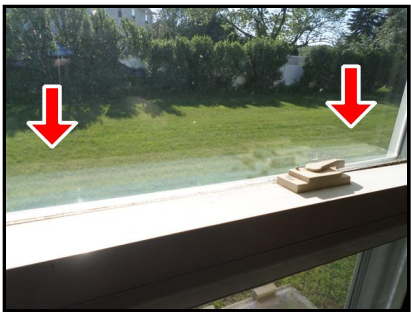
6.4.E Item 1(Picture)
misaligned window

6.4.E The window in bedroom 2 will not properly close. This may be due to improper installation or settlement. Recommend further evaluation and repair by a qualified window contractor.

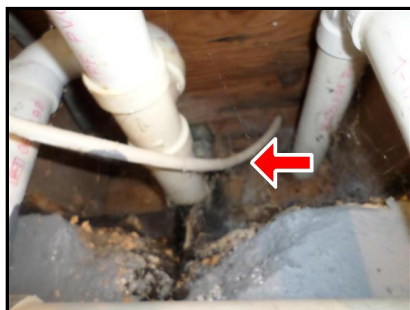
7.5 Item 1(Picture) sink drain

7.5 The kitchen sink drain line has a leak. This is observable from the basement laundry room. This condition if allowed to continue will cause waste water to flow into the basement area. Recommend evaluation and repairs by a qualified plumber.

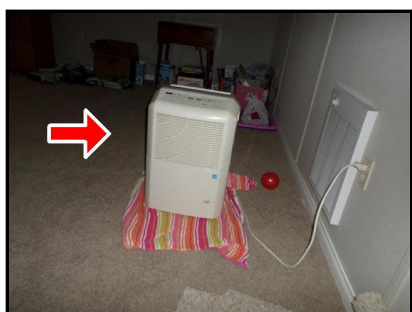
8.0 Item 1(Picture)
dehumidifier

8.0 Dampness in the basement is also a concern to people with allergies or other medical conditions because dampness can increase the risk of mold growth. A dehumidifier is often required in the basement to control the dampness. In humid and damp climates a dehumidifier can pull as much as 50 pints of water from the air each day, depending on the size of the system. Keep your dehumidifier's reservoir clean and dry; don't let water spill over or stagnate when not in use. Install a catch pan under the humidifier to prevent staining the carpet. A dirty or poorly maintained dehumidifier wastes energy and can overheat. Ideally the dehumidifier should drain to a sump pump basin which would then discharge to outdoor surface. An ejector pump attached to the dehumidifier would reduce maintenance requirements.

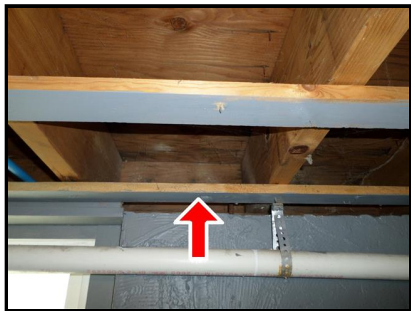
8.5 Item 1(Picture) perimeter sill no insulation

8.5 Some areas of the perimeter sill are not insulated. The perimeter sill is a major area of heat loss. Recommend insulation to improve the energy efficiency of the home. No insulation between the floor joists was observed.

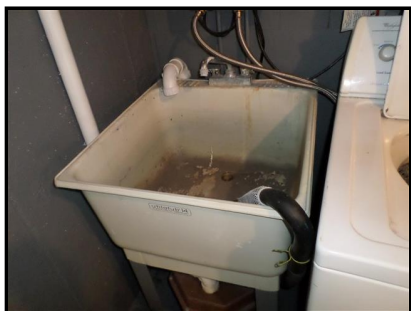
8.8 Item 1(Picture) basement sink

8.8 The wash machine discharges into the sink. Recommend an additional sink drain screen to prevent clogging the drain line.

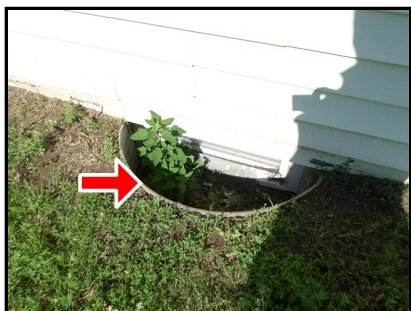
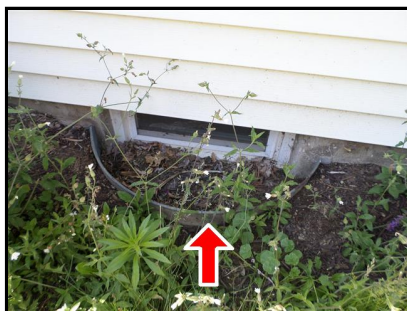
8.9 The window wells around the house are filled with debris. This may cause water to pool and enter the basement. Recommend cleaning out the window wells as required.

8.9 Item 1(Picture) debris in window well

8.9 Item 2(Picture) debris in window

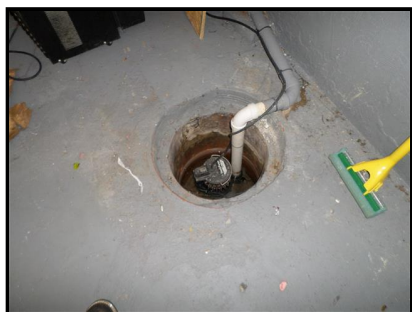
9.6 Item 1(Picture) sump pump

9.6 The sump pump is located in the utility area in the basement. Recommend that all sump pumps have a battery back up installed. Most areas in New York are subject to power outages during the wet seasons which may cause the sump to not operate. An increased risk of basement flooding may also incur when home owners are not in the home. a sump pump should be connected to a GFCI circuit. The sump pump should be powered by a safe, secured, properly wired electrical circuit and receptacle. Wet locations sometimes keep tripping off the GFCI - a safe condition, but it means the building is likely to become flooded because the circuit powering the sump pump has shut down. Where a sump pump is relied-upon heavily to keep water out of a building, good practice includes an alarm to inform someone when the pump is not operating. in areas prone to power failures the sump pump may be a battery-backup installation. The batteries are connected to a charging system and are available to operate the pump when area electrical power has been lost. The sump crock should have a cover installed to prevent foreign objects from clogging the sump pump.

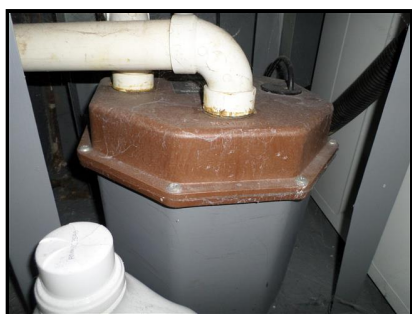
9.7 Item 1(Picture) sewer ejector pump

9.7 The sewer pump was operating at the time of inspection.

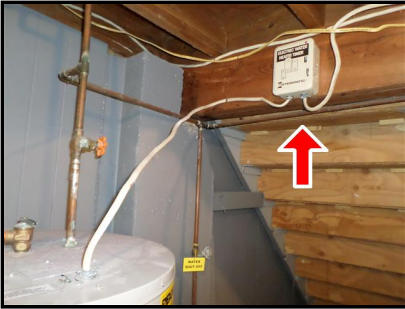
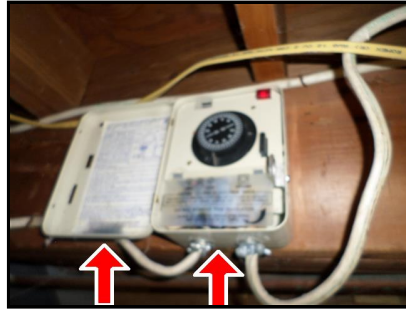
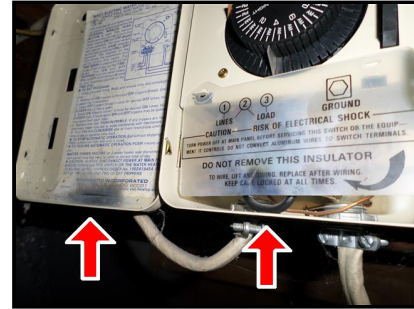
10.3 Some overheating in the water heater timer box was observed. Recommend monitoring and have the box evaluated by an electrician if further problems occur. The water heater wiring is not properly secured and shows poor workmanship. Recommend properly stapling the wire in a secure manner to minimize accidental pulling and damage.

10.3 Item 1(Picture) hot water heater timer

10.3 Item 2(Picture) over heated wire

10.3 Item 3(Picture) timer box

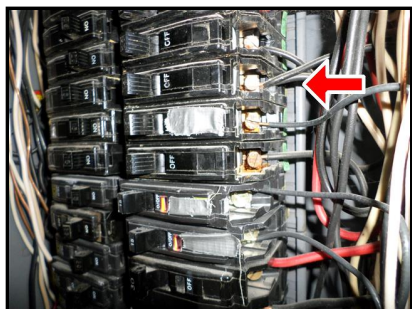
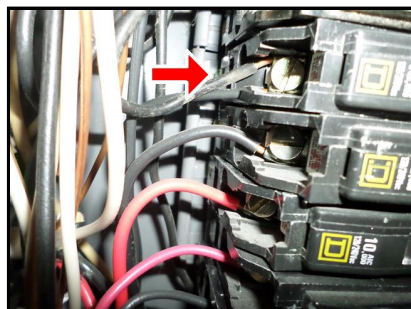
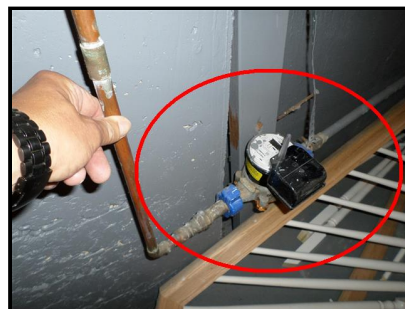
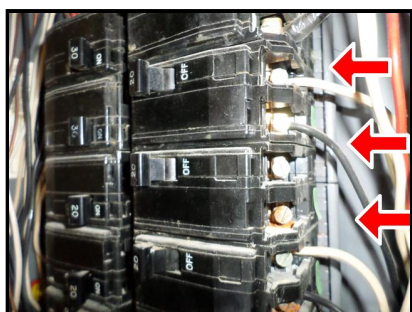
11.1 More than one wire is observed at individual electrical disconnects. Manufacturer requirements dictate that only one wire is to be connected to this type of disconnect. A jumper cable over the water meter/pressure regulator was not found. The jumper cable provides a proper ground to the electrical system in the home. Questionable grounding provisions should be checked/confirmed by a qualified electrician prior to closing. Some corrosion on the circuit breaker connector screws was noted. Excessive humidity and moisture in the basement may cause rust in the panel box. This condition if allowed to continue can cause the circuit breaker not to trip due to a bad connection. The labels on the panel are difficult to read. This may be due to numerous upgrades since the panel was installed. Proper labeling reduces accidental shock while working on the electrical system. Recommend evaluation and repairs by a qualified electrician.

11.1 Item 1(Picture) double tap circuit breaker

11.1 Item 2(Picture) double tap circuit breaker

11.1 Item 3(Picture) missing jumper cable

11.1 Item 4(Picture) corrosion on screws

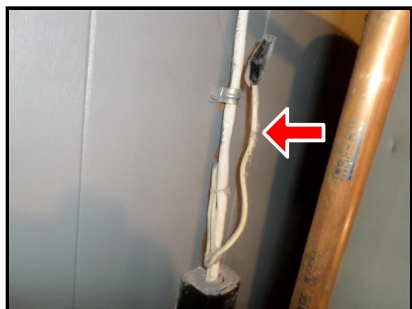
11.2 Item 1(Picture) un-secure wire

11.2 A wire was noted outside the dryer 220 amp outlet. The wire is not hot and is improperly taped. This wire should be terminated inside the electrical outlet. Recommend repairs by a qualified electrician.

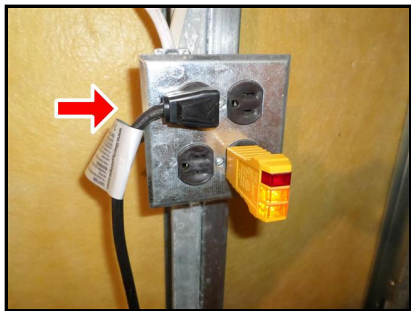
11.4 Item 1(Picture) laundry room / sump pump circuit

11.4 Normal construction practices require GFCIs installed in the bathroom, garage, outdoors, laundry areas and in a kitchen within 36 inches of a wet area. Any surface exposed to the weather is considered a wet area. Recommend proper installation of a GFCI feed through receptacle outlet by a qualified electrician. A GFCI may be in the panel box but long runs may cause nuisance tripping.

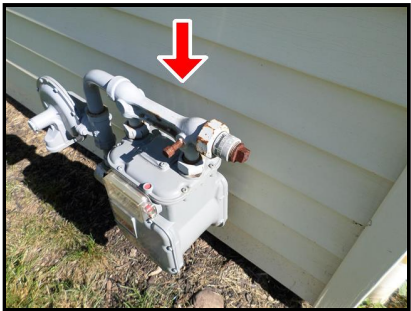
12.5 Item 1(Picture) gas meter missing bracket

12.5 The gas meter is not connected to the home. The meter does not have a mounting bracket attaching it to the house. This condition allows the meter to free stand and is subject to damage from lawn mowers or other objects striking it. Recommend contacting RG and E they will provide the homeowner with a gas meter wall bracket. The homeowner is responsible for installing the bracket in a level position. The bottom of the bracket shall be located two (2) inches above finished grade. The bracket should be solidly mounted to the structure with 3/8-inch bolts with expansion anchors, tapcons or other suitable means.
