Inspection Report

Property Address:
183 Harwood Circle
Penfield New York 14625

VETERANS HOME INSPECTION SERVICES

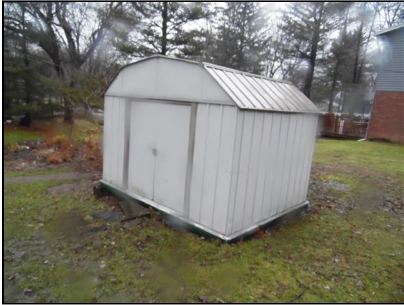
2.10 shed

I did not inspect any additional buildings. I only inspected the main structure. Deficiencies may exist with these structures or building (s). Our company makes no representation to the condition of these structures or building (s). Check with your local building dept for permit requirements.

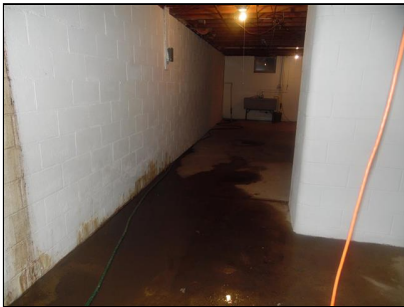
8.0 pooling water

If mold growth is found, regardless of the magnitude of the growth, it is recommended that the growth be physically removed using appropriate controls and precautions. If mold has been located and removed, it is also important to identify and correct the source of moisture or dampness that allowed the mold to grow. If the affected area becomes moist again, mold growth will occur again. We recommend that you consult a mold mitigation company if you are not familiar with how to locate and safely remove mold growth or how to identify and correct moisture problems that may exist. All allergy or medical-related questions and concerns, including health concerns relating to possible mold exposure, should be directed to a qualified physician. Further evaluation by a trained mold professional or a Certified Industrial Hygienist (CIH) may be advisable prior to closing. Blackened areas were detected on the walls. This may be caused by excessive moisture near the sink. Cleaning the walls and painting with a moisture resistant paint may improve the dryness and mitigation of blackened areas. Consider improving the ventilation in the basement. Painted over spalling was noted on the basement foundation. This condition is due to below ground water exiting through the walls and freezing. The freezing causes the masonry block to split/chip called spalling. Recommend installing a better drain system around the house to prevent ground water entering the foundation. The front and back right corners of the basement foundation has active signs of water penetration. The back wall also has water penetration. This may be due to a clogged downspout and underground drain. Recommend testing the gutter drain system by spraying water into the gutter and watch to see if the gutter drains properly. Check for clogging in the underground drain and basement. Clean gutters and clear the underground drain as required. See par 8.9 Multiple areas of water penetration were observed. This may be caused by pooling water on the exterior foundation. Cleaning the walls and painting with a mold resistant paint may improve the dryness and mitigation of mold. Consider improving the soil grade around the foundation. Ensure that the downspouts are not clogged. Add soil to improve grade away from the house. The basement walls have been recently painted with a water resistant paint sealer (dry loc). The paint will minimize water penetration but also masks previous water issues. Recommend monitoring the basement for water penetration and consult with a foundation contractor for further evaluation and repairs if required. Consider installing weep holes in the lower basement walls. This condition allows the lower block water drainage to occur. A drain tile or french drain system will capture the water entering the block system and drain the water into a pit where a sump pump will discharge it from the building. An interior drain drain is much less likely to clog than an exterior, partially due to the fact that it is not sitting underneath several feet of soil. The weep holes are drill at the lowest course of block. The bed joint is below the lowest course of block. The bed joint is the layer of mortar that the first course of block is installed upon. Where possible, the lowest course of block is tapped above the bed joint and bled (weep holes) in order to drain the walls.

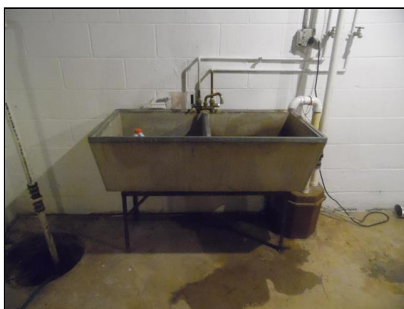
8.7 basement sink

The basement sink does not have a proper j-trap installed. Recommended installing proper plumbing by a qualified plumber. The ejector pump was not operating at the time of the inspection. The ejector pump dedicated outlet was not protected by a GFCI. Recommend further inspection and replacement by a licensed plumber/electrician.

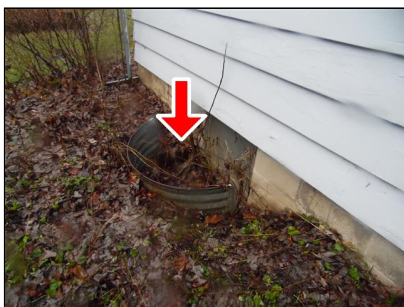
8.8 disconnected window wells

Older style windows with exposed wood trim were noted. Maintain caulk, paint and glazing to minimize water damage. This condition will allow water and insects to enter the walls. Sealing the windows improves energy efficiency. Recommend repairs by a qualified contractor as required. The window wells are dislocated from the foundation wall. This condition will allow water to drain into the window well. Remove the window well. Dig out the area and place the window well back into the hole using four bricks under the window well as a foundation to rest on. Secure the window well to the foundation using tapcon screws. Recommend reinstalling the window wells. The basement windows do not have window wells. Water penetration through the basement window frame was noted in the basement. Recommend installing glass block windows with a vent during future upgrades. One window has broken glass. Recommend replacement as required. See par 2.5

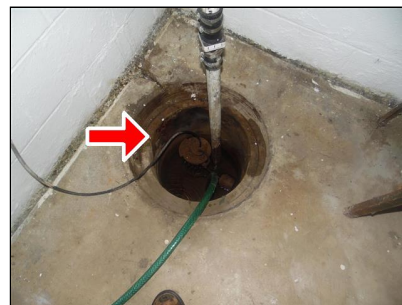
9.5 sump pump

Sump pumps should have a battery back up installed or connected to a generator. Most areas in New York are subject to power outages during the wet seasons which may cause the sump to not operate. An increased risk of basement flooding may also incur when home owners are not in the home. The sump pump should be powered by a safe, secured, properly wired electrical circuit and receptacle. Where a sump pump is relied-upon heavily to keep water out of a building, good practice includes an alarm to inform someone when the pump is not operating. In areas prone to power failures the sump pump may be a battery-backup installation. The batteries are connected to a charging system and are available to operate the pump when area electrical power has been lost. Sump crocks should be covered to prevent items falling in and gases from under the basement floor entering the house. Consider purchasing a second standby backup sump pump if a replacement is needed. The electrical cord for the sump pump is hanging from the outlet and is too high to reach for average person. This condition may allow the cord to be pulled out of the outlet and makes it difficult to plug in or remove. Recommend installing a board and lowering the outlet and wire run for easy access.

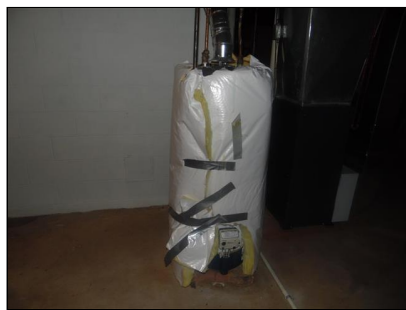
The water heater was shut off and not operating. Recommend having the home owner turn on the water heater for inspection prior to closing. See par 9.0
